STATE PROJECT NO. 92-669

**Rehabilitation of Bridge 03014A I-91 NB over Mill  
River, State Street, Ramp 140**

**Design Inspection Memo**

**Bridge No. 03014A  
I-91 NB over Mill River, State Street & I-91 NB Ramp 140  
New Haven, CT  
Project No. 92-669**

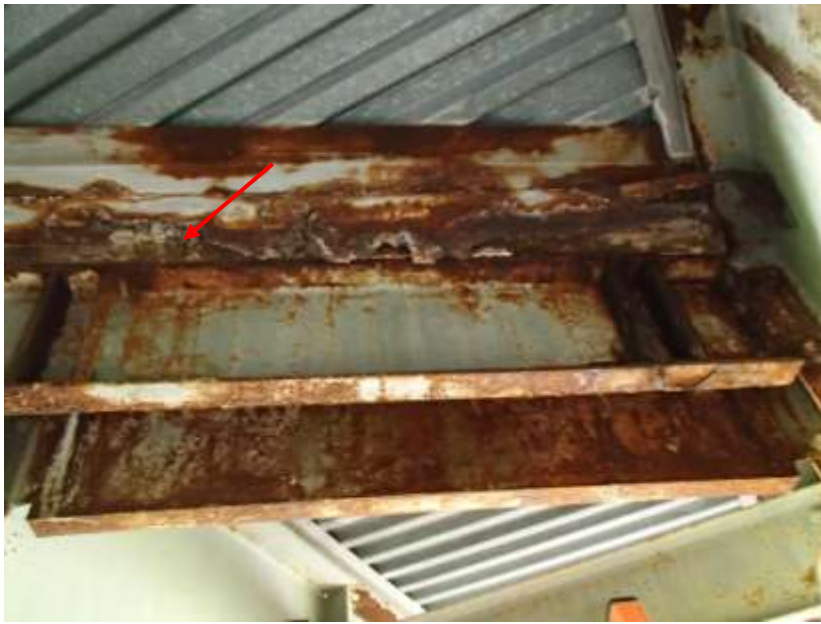
- The SIP forms at the deck end haunch exhibit areas with heavy rust and perforations, up to 6' long by 1' wide at approximately 60 locations. See Photo 5 and framing plan field notes.

**Photo # 5: Typical condition of SIP form at end diaphragm with active corrosion. Note the 5' long x 1' wide area of heavy rust with perforation holes.**

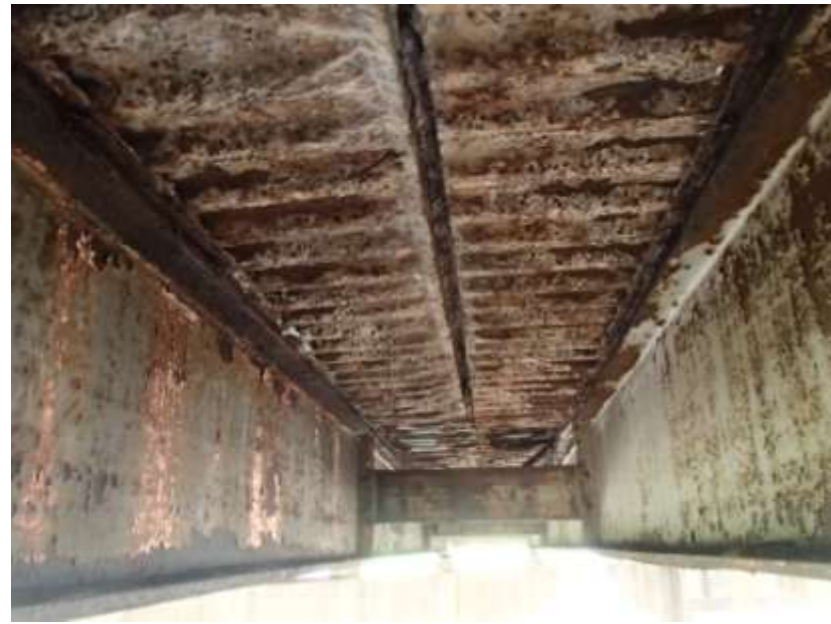
- The SIP forms are also deteriorated at isolated locations other than at the deck end haunch, with the largest area being in Span M, Bay 7 which exhibits 100% deterioration. See Photo 6 and framing plan field notes.

**Photo # 6: Underside of deck between G7 and G8 in Span M exhibits 100% deterioration of SIP forms.**

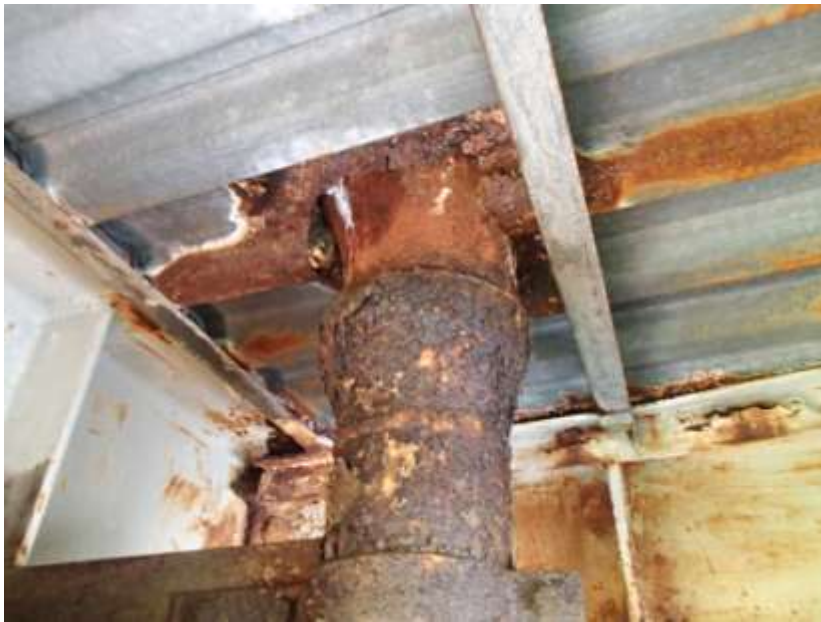
- All scupper drain pipes exhibit heavy laminated rust and isolated drain pipes have PVC sleeves installed around the deteriorated pipes at random locations. See Photos 7 and 8.

**Photo # 7: Typical condition of scupper drain pipes with heavy laminated rust. Also note area of heavy rust to SIP forms around the scupper drain.**

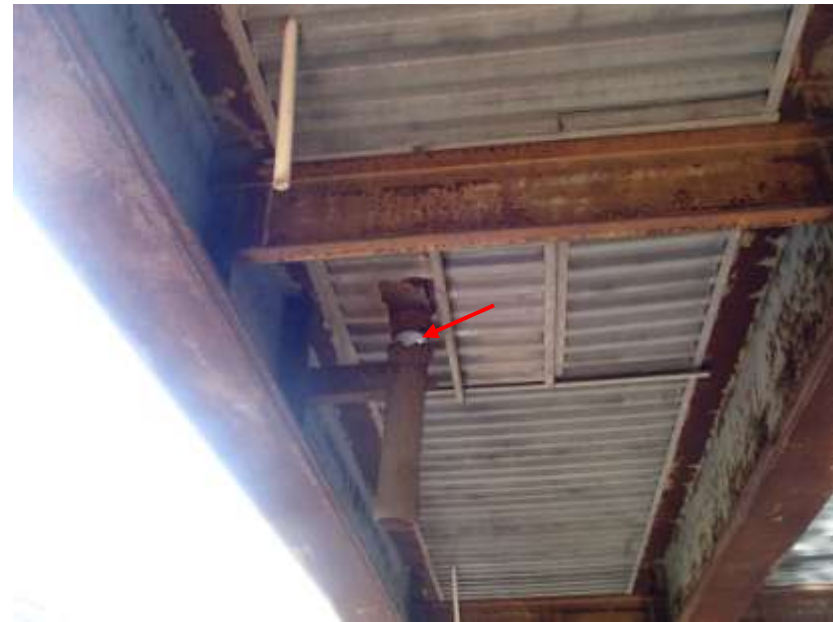
**Photo # 8: Broken and disconnected scupper drain pipe in Span D adjacent to G11.**

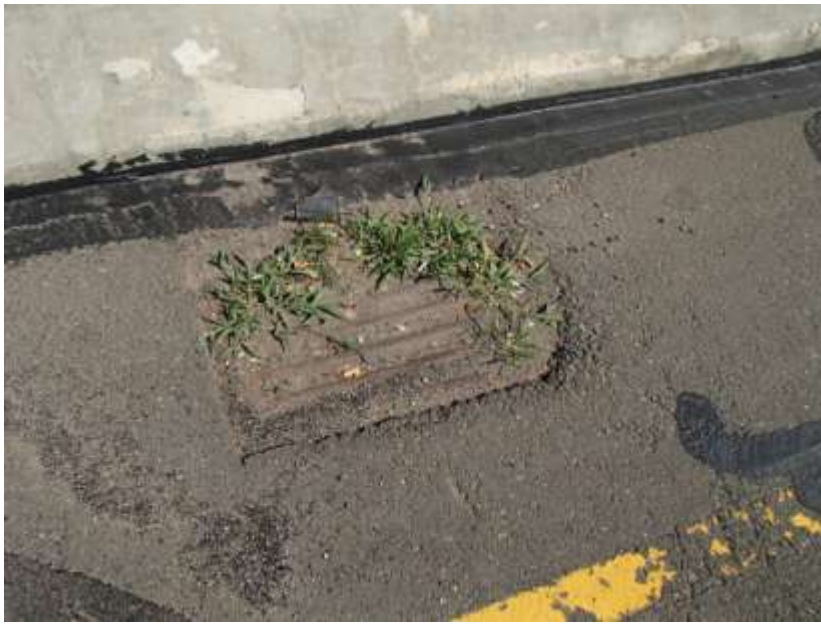
- The scupper grates along the west curb in Spans A and J are fully clogged. See Photo 9.
- There is section loss in the bottom of the web at majority of the girders ends. The typical section loss measures 3' long x 4" high x up to 3/16" deep. See Photos 10 – 12 and field notes.

**Photo # 9: Fully clogged scupper grate at the west curb in Span J.**

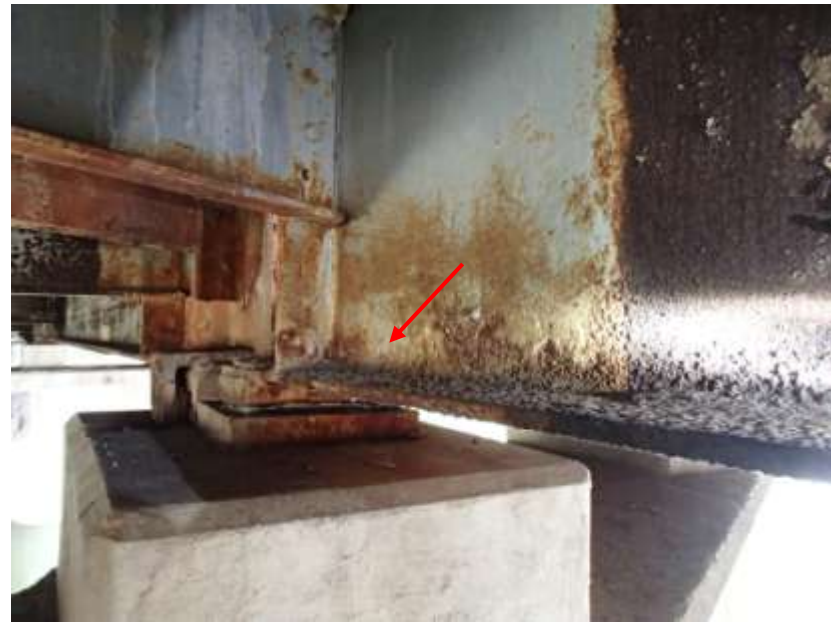
- There is section loss present on the top of the bottom flange in majority of the beams. The typical section loss measures 3' long x full width of flange x 1/8" deep. At random locations, the section loss measures up to 1/4" deep. See Photos 10 & 17 and field notes.

**Photo # 10: In Span I, at Pier 8, the east side of G4 exhibits 2'-6" long x 5" high x 3/16" deep section loss at the bottom of the web. Also note the section loss to the top of the bottom flange, 3' long x full width x 1/8" deep.**

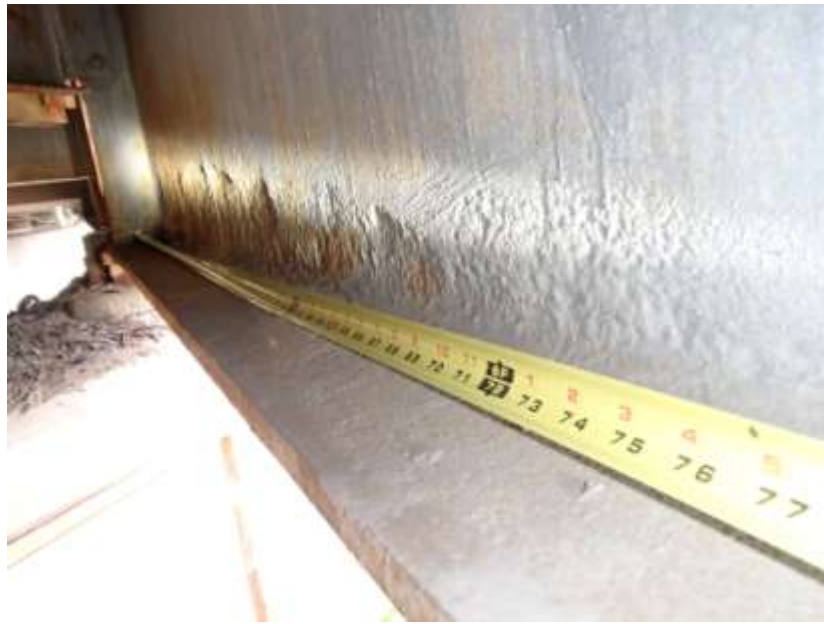
**Photo # 11:** In Span K, at Pier 11, the west side of G14 exhibits 6'-6" long x 7" high x 3/16" deep section loss at the bottom of the web.

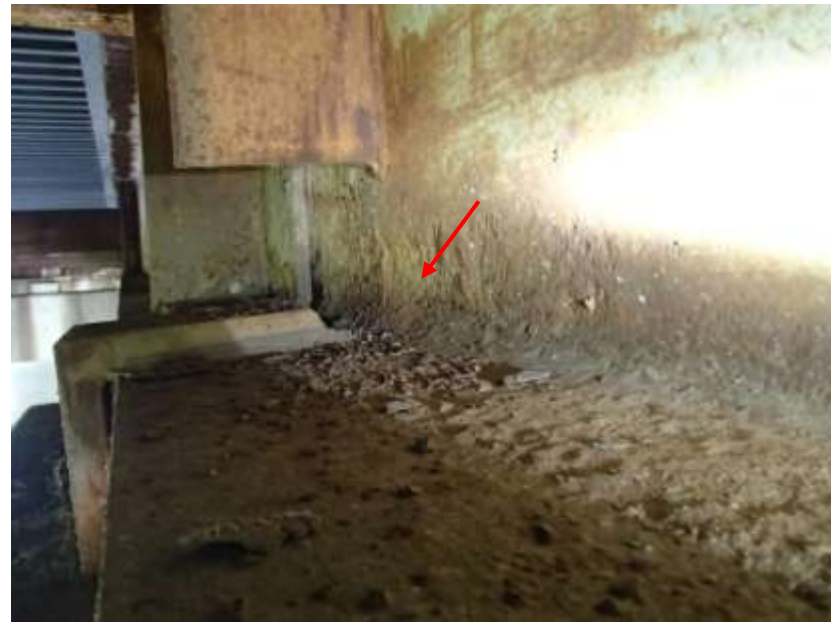
**Photo # 12:** In Span B, at Pier 2, the west side of G7 exhibits 2' long x 5" high x 1/8" deep section loss at the bottom of the web.

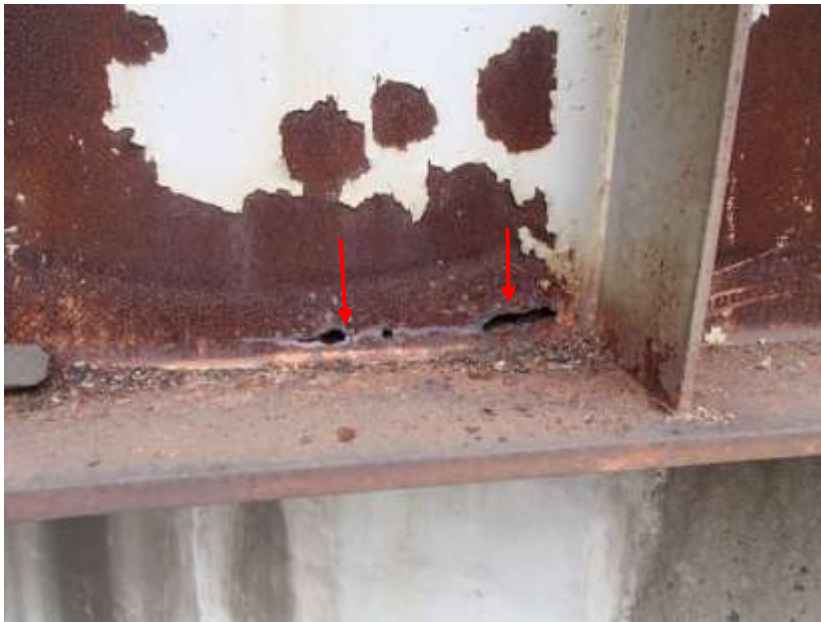
- Three new perforations up to 3 1/2" long x 1" high were found in G9, Span J, near Pier 10. See Photo 13 and field notes.
- The webs at girder ends are bowed by up to 7/8" (typically at the bottom 1/3<sup>rd</sup> of the web) at approximately 30 locations (in 10 of the 15 spans, but mainly in Spans J, K, L and M). See Table 1, Photo 14 and field notes.

**Photo # 13:** In Span J, at Pier 10, G9 exhibits three perforations to bottom of the web up to 3 ½” long x 1” high.

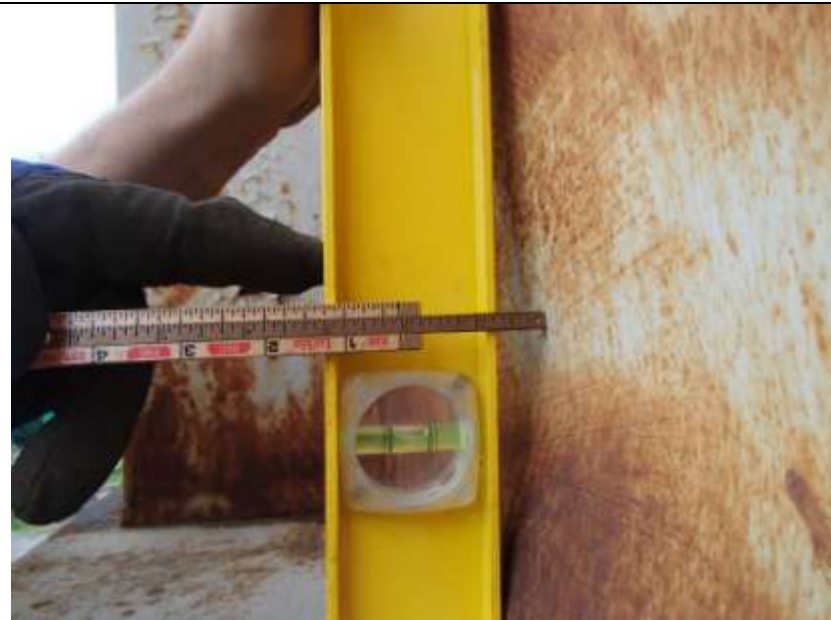
**Photo # 14:** In Span J, at Pier 10, G9 exhibits a 2’ long x 10” high x ¾” deep bow in the bottom of the web.

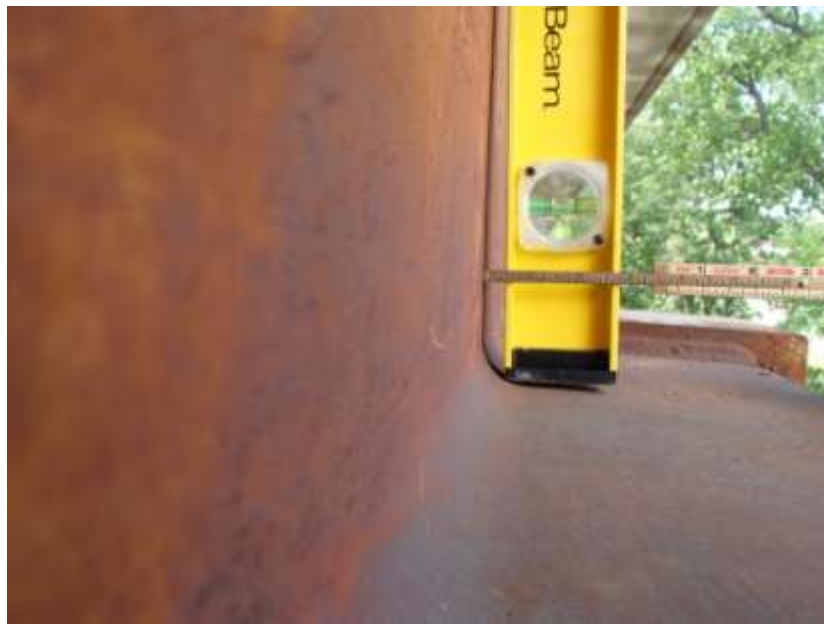
- The girder ends are tipped by up to 1/2" over 2' at approximately 60 locations (in 13 of the 15 spans). At a majority of these locations, there is heavy impacted rust between the bearing plates. See Table 2, Photos 15 & 16 and field notes.

**Photo # 15:** In Span B, at Pier 2, G15 is tipped east  $\frac{7}{16}$ " over 2'.

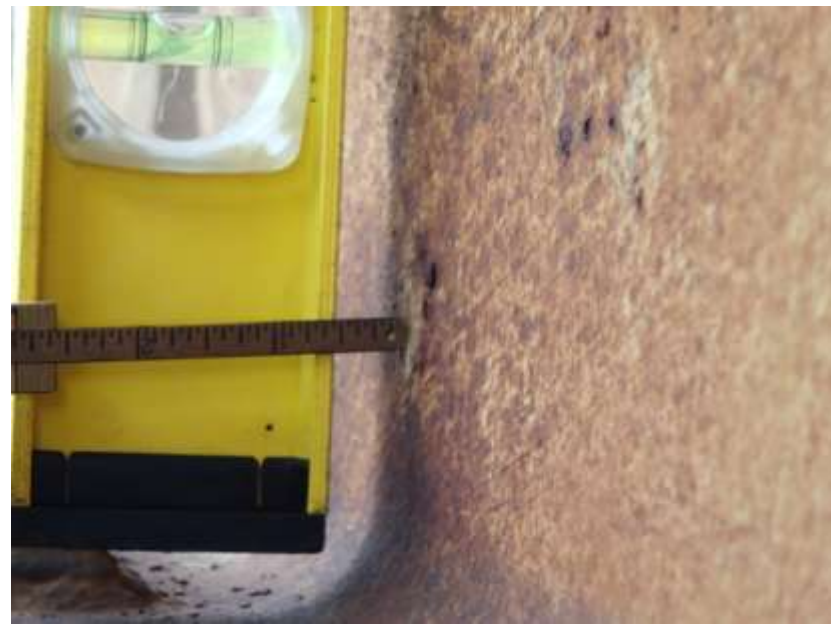
**Photo # 16:** In Span C, at Pier 3, G1 is tipped west  $\frac{1}{2}$ " over 2'.

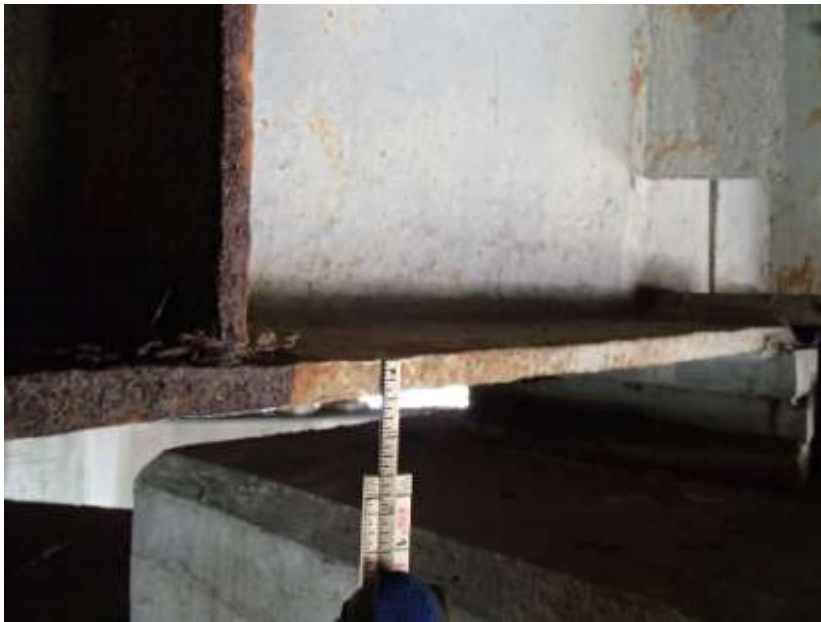
**Photo # 17:** In Span H, at Pier 8, G7 exhibits 1/4" deep section loss to the bottom flange.

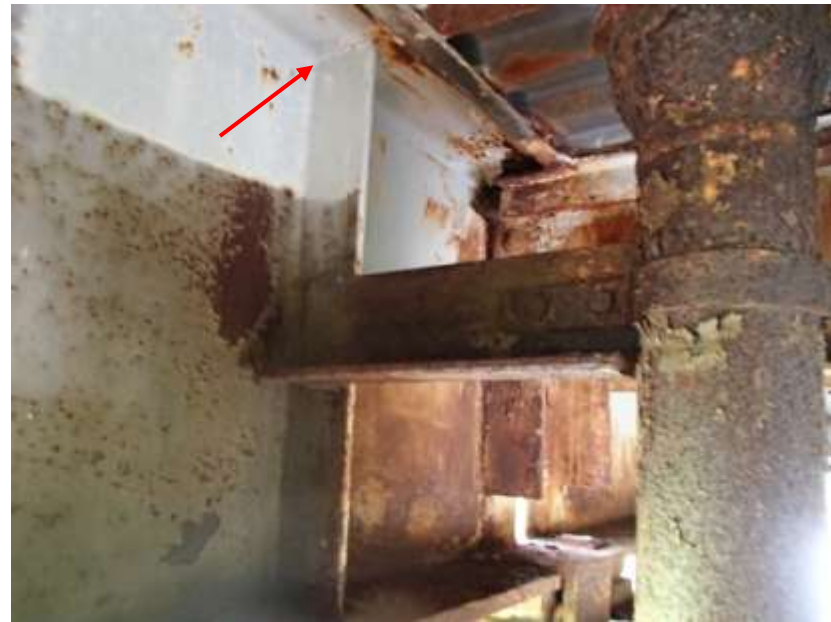
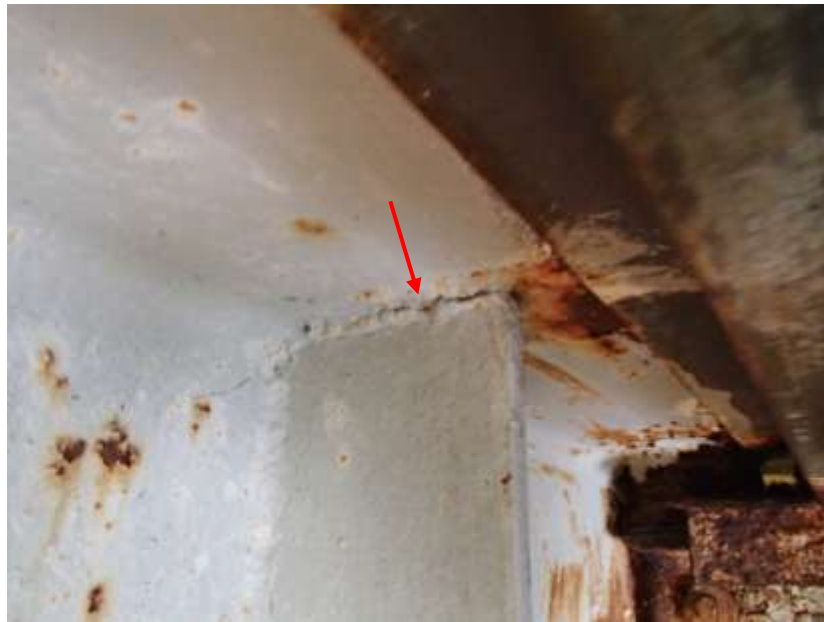
- Cracked/missing welds were observed at the following locations (see Photos 18 – 21 and field notes):
  - Span B, east side of G1, near Pier 2 – cracked weld between the connection plate for scupper pipe and top flange

**Photo # 18:** General view of the cracked weld between the top flange and the connection plate in Span B, near Pier 2, on the east side of G1.

**Photo # 19: Close up view of Photo 18.**

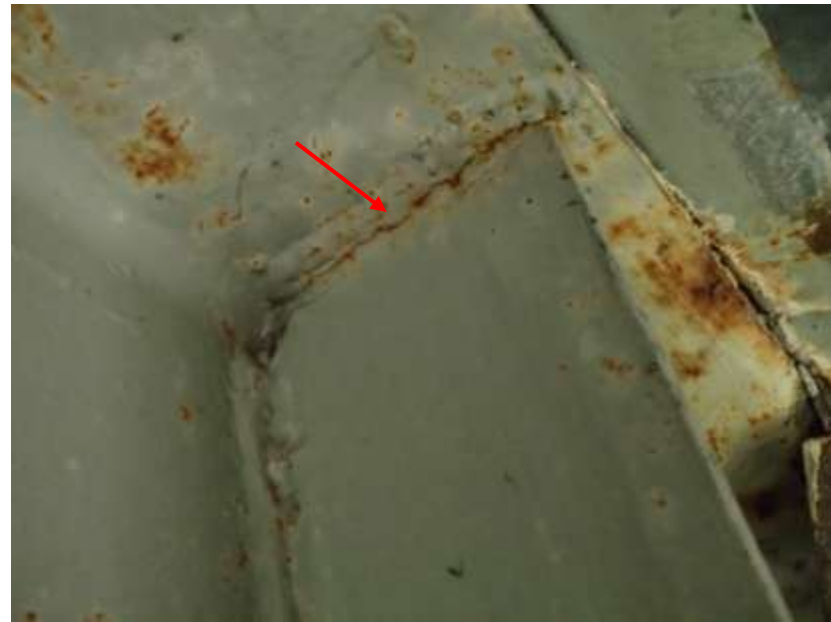
- Span J, G3 at Pier 9 – cracked weld between lower connection plate and vertical stiffener connection at the end diaphragm
  - Span M, west side of G2 near Pier 12 – cracked weld between the connection plate and the top flange at the first interior diaphragm.

**Photo # 20: Close up view of the cracked weld between the top flange and the connection plate at the first interior diaphragm in Span M, near Pier 12, on the west side of G2.**

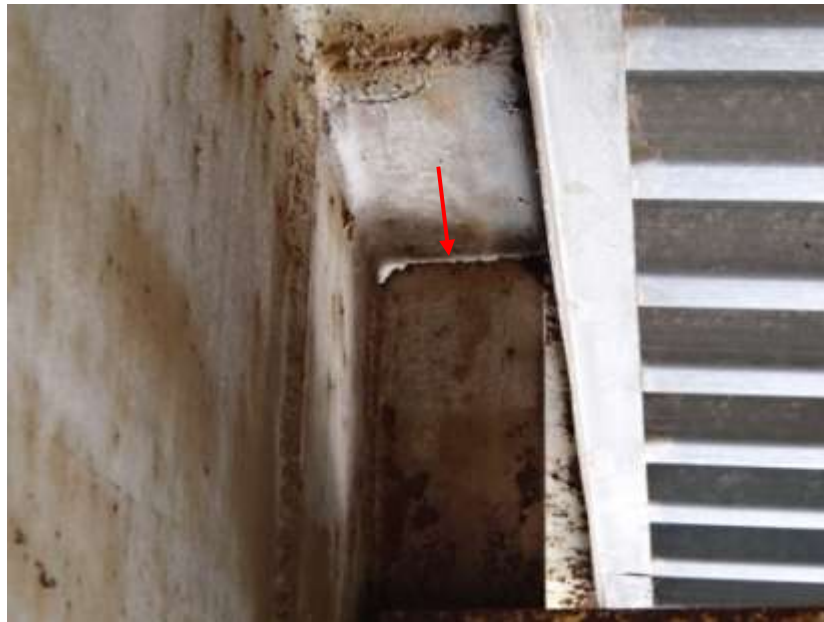
- Span I, west side G3 near Pier 9 - missing weld between the connection plate and the top flange at the first interior diaphragm.

**Photo # 21: Missing weld between the connection plate and the top flange at the first interior diaphragm in Span I, near Pier 9, on the west side of G3.**

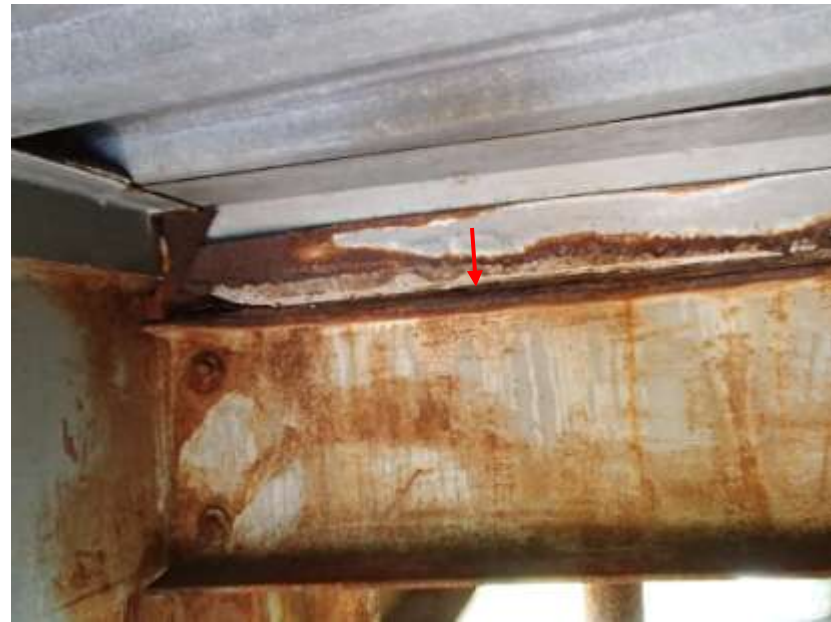
- Span M, east side of G9 & west side of G10 near Pier 12 - missing weld between the first interior diaphragm and the connection plate.
- The end diaphragms typically exhibit 1/16" deep painted over section loss on the channel web and flanges. Random locations exhibit active corrosion areas with section loss up to 3/16" deep, knife edges and perforations. See Photos 22 & 23 and field notes.

**Photo # 22: End diaphragm in Span C, at Pier 2, in Bay 16 exhibits 3' long x 3" wide x 3/16" deep section loss to the top flange and 3/4" impacted rust between the top flange and SIP form.**

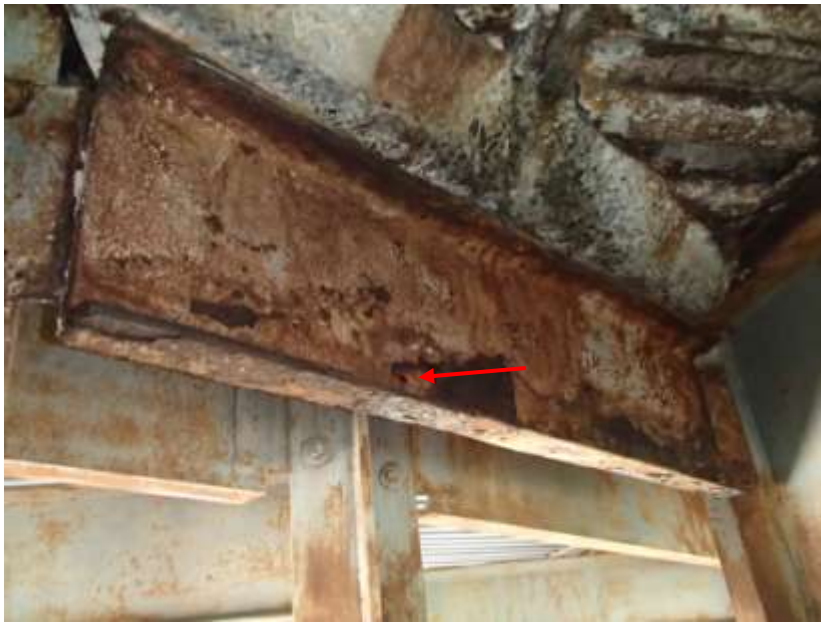
**Photo # 23: End diaphragm in Span M at Pier 12 in Bay 7 exhibits heavy deterioration with a maximum of 1/8" remaining to flanges and web. Also note 3/4" diameter perforation in the web.**

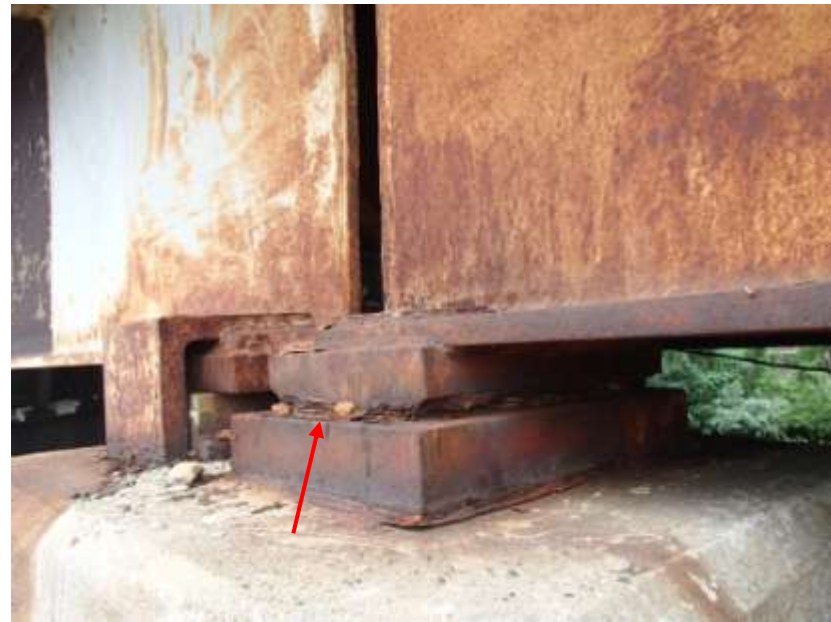
- The fixed bearings typically exhibit up to 3/8" impacted rust between the sole plate and the masonry plate. All anchor bolts have been cut/removed and plated over. Fixed bearings at two locations (Span D, G7 at Pier 3 and Span H, G8 at Pier 7) exhibited excessive movement under live loading with the presence of abrasion rust. See Photos 24 & 25 and field notes.

**Photo # 24: Typical condition of the fixed bearings with up to 3/8" impacted rust between sole plate and masonry plate. Also note that the anchor bolts have been cut/removed at all fixed bearings and plated over.**

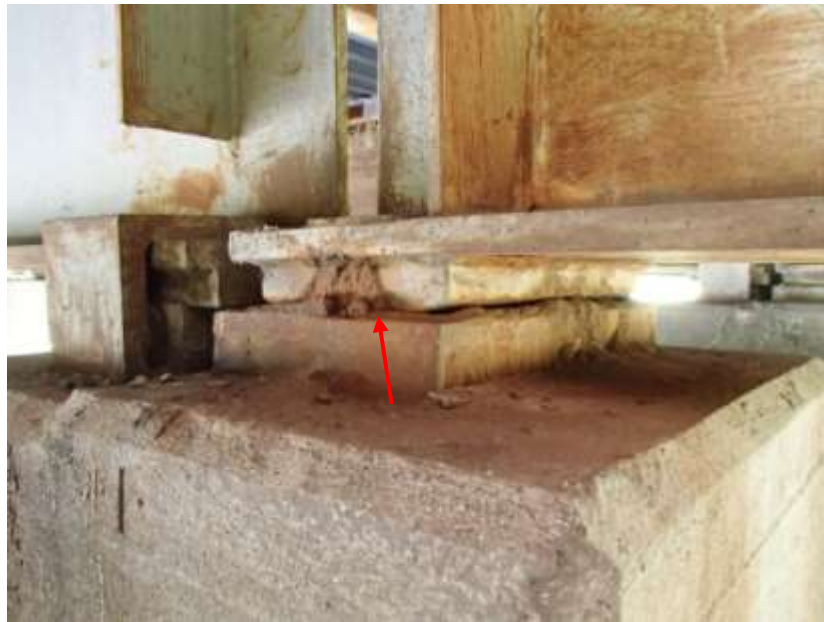
**Photo # 25: Fixed bearing under G7 in Span D at Pier 3 exhibits excessive movement under live load with the presence of abrasion rust.**

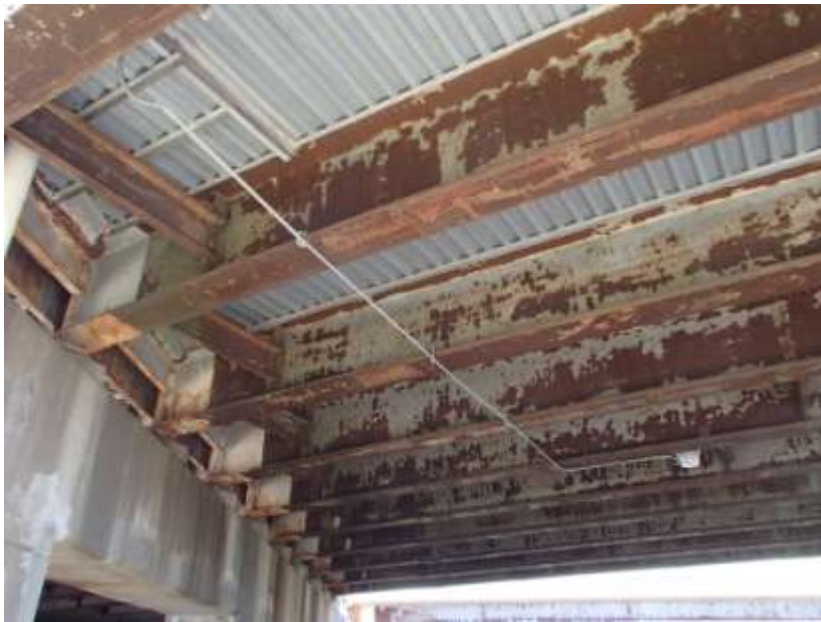
- The paint system has failed throughout. See Photos 27 & 28 and field notes.
- There are multiple disconnected conduits with exposed wires attached to the south side of Pier 13. There are utility conduits welded to the bottom flanges in Span M near Pier 13 resulting in fatigue prone details. See Photos 29 and 30 and field notes.

**Photo # 27: The paint system has failed, Span N shown.**

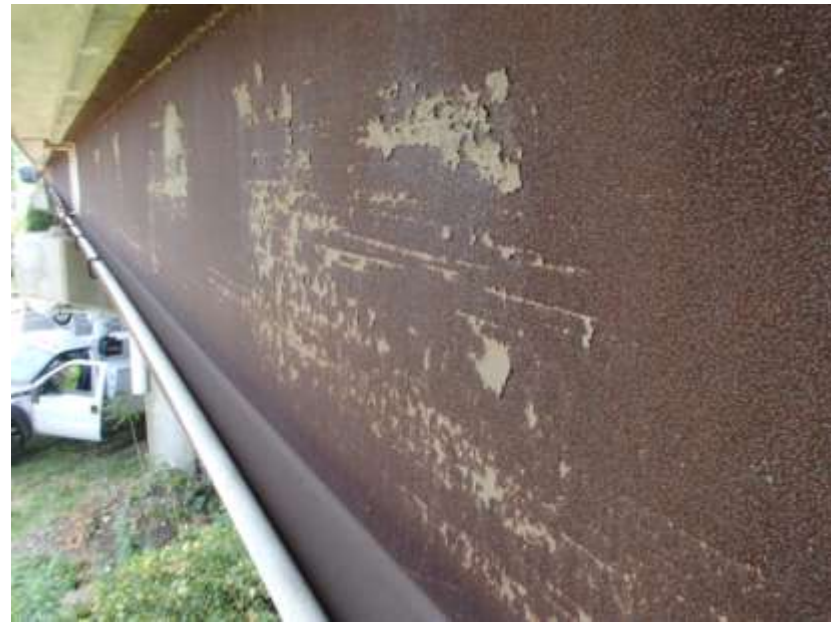
**Photo # 28: The paint system has failed, Span O shown.**

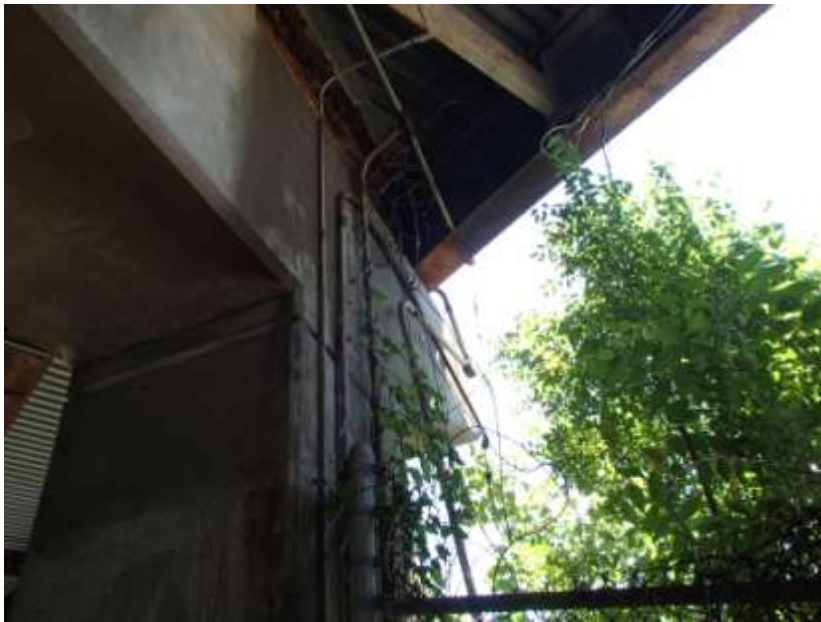
**Photo # 29: Multiple disconnected conduits with exposed wires at the south side of Pier 13.**

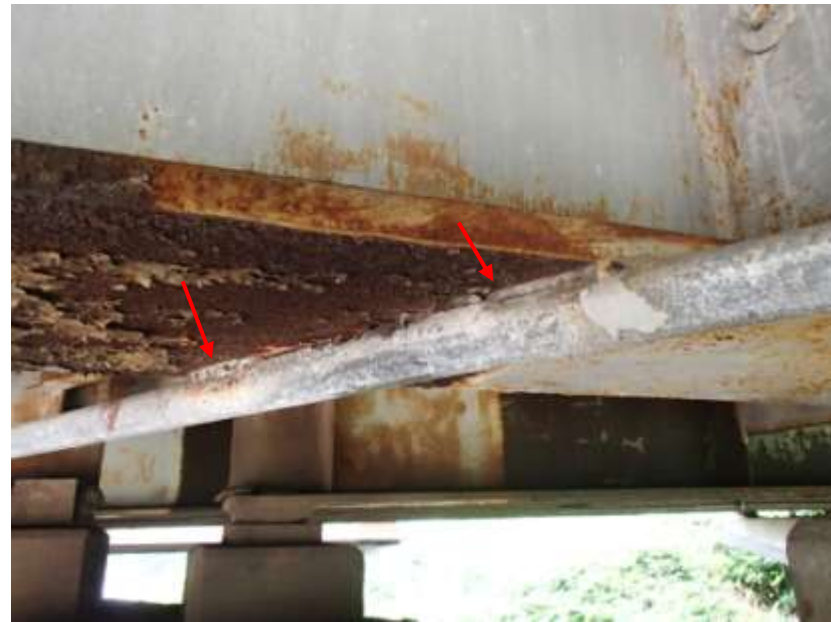
**Photo # 30: Utility conduits welded to the bottom flanges in Span M, near Pier 13.**
